How to ALM alarm appears in the system -- Thunder-XPRO

→ Problem: ALM alarm appears in the system --Thunder-XPRO;

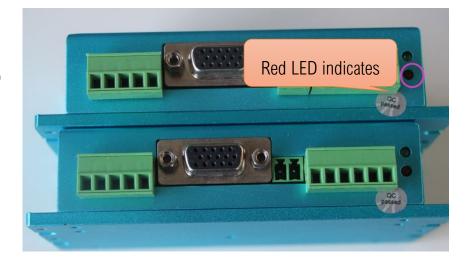
Red LED indicates status description:

Priority	Time(s) of Blink	Sequence wave of RED LED	Description
1st	1	5S 5S	Over-current protection
2nd	2	55S	Over-voltage protection
3rd	7	55	Position Following Error

When the drive fails, the drive will stop and the user needs to power off.

When the power is turned on again, the fault can be cleared.

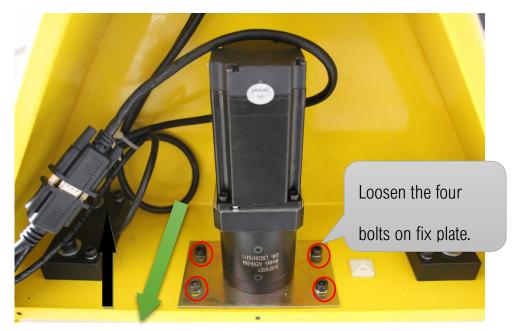
As: The machine received an external impact; The single-motor movement of the Y-axis causes the machine to deform; causing driver alarm and system alarm;

Solution: Step 1- Separate the gears of the Y1 and y2 motors from the rack, Move the motor to the direction of arrow, as Pic shows,

Ensure the rack and gears are separated. Then tighten the one bolts on fix plate

The same method separates the gear of the Y2 axis motor from the rack;

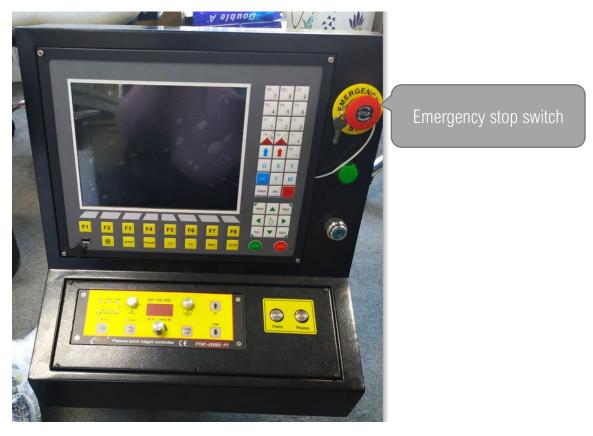
* 2. Emergency stop switch turned on, causing alarm.

Solution: Step 1- Emergency stop switch turned off, as Pic shows,

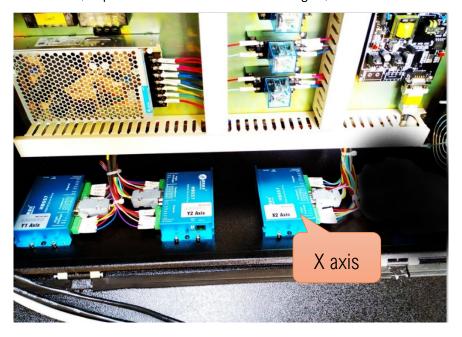
★ 3. Drive is damaged.

Solution: If Y-axis drive damaged; Switch the alarm driver to the X-axis driver-Beam axis. So This can be tested without removing the motor;

Switch the alarm driver to the X-axis driver-Beam axis. → Press the X axis direction key on the system keyboard.

If the drive does not alarm, the X-axis motor is running; It proves that the motor driven by the alarm is damaged; **The motor needs to be replaced**;

If the drive does alarm; It proves that the driven is damaged; The Drive needs to be replaced;

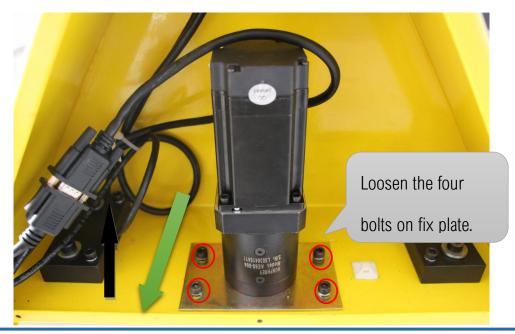
If X-axis drive damaged; Switch the alarm driver to the Y-axis driver-Beam axis; Need remove the motor for the Y1 and y2 axes; --Then test;

Step 1- Separate the gears of the Y1 and y2 motors from the rack, Move the motor to the direction of arrow, as Pic shows,

Ensure the rack and gears are separated. Then tighten the one bolts on fix plate. The same method separates the gear of the Y2 axis motor from the rack;

Note: The rack and gears are separated, In order to ensure the synchronization of Y1 and Y2
